WHERE THE RIVER MEETS THE DITCH:
HUMAN AND NATURAL IMPACTS ON THE GILA RIVER, NEW MEXICO, 1880-2000

A Thesis
Submitted in Partial Fulfillment
of the Requirements for the Degree of
Master of Arts
in Rural Geography

Northern Arizona University

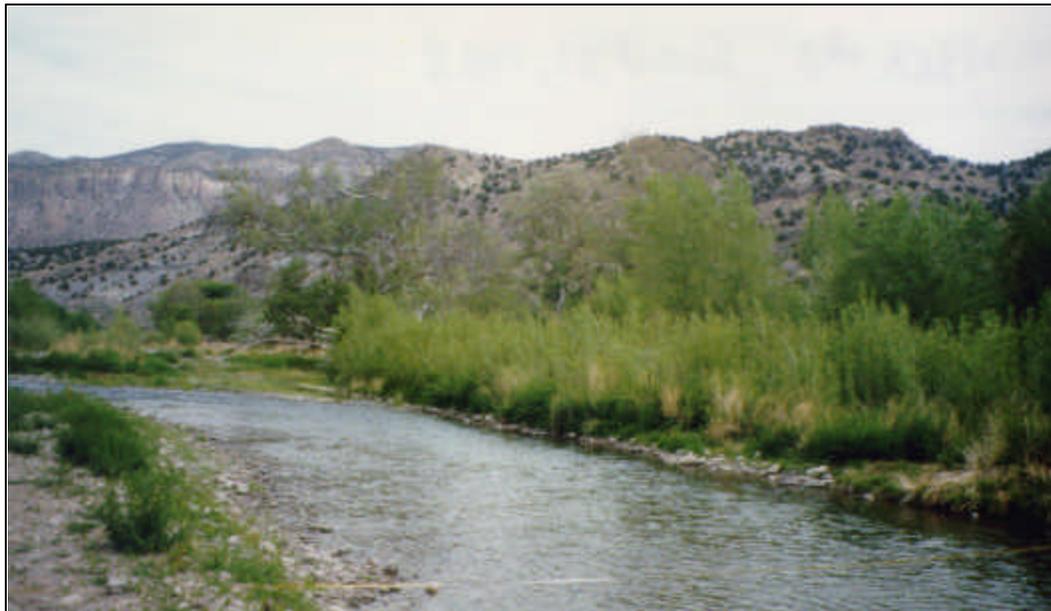
Figure 7. Looking upstream at cross-section 2 location, May 1999.

colonized some of these. Ten cross-sections were surveyed as part of the study (see Methods, below), and photographs of selected cross-sections taken in 1999 appear in Figures 7 through 14. For reference, cross-section locations appear in Figure 5.

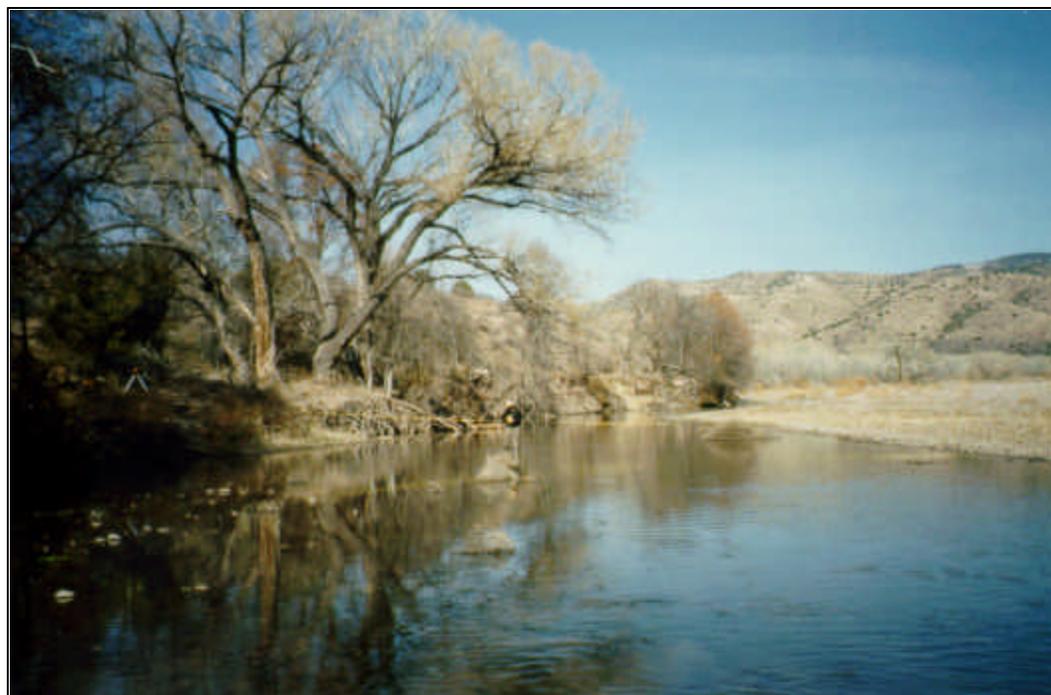
Figure 8. Looking upstream at cross-section 3 location, March 1999. Upper Gila ditch is approximately 10 feet above water surface upstream of large cottonwoods on left side of photo.

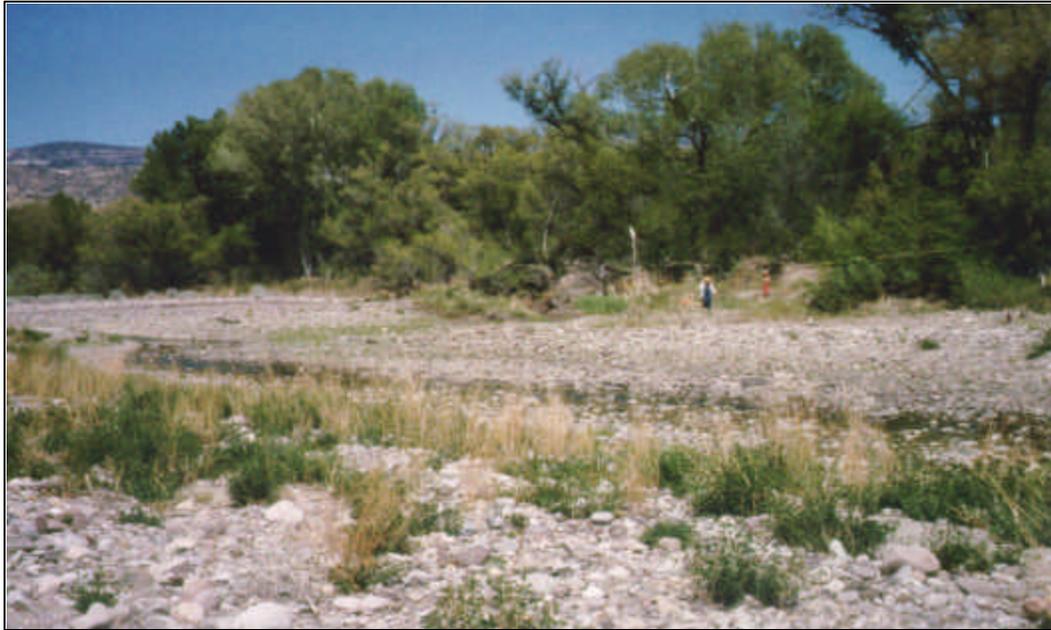
Figure 9. Looking upstream and across channel at cross-section 4 location, May 1999.

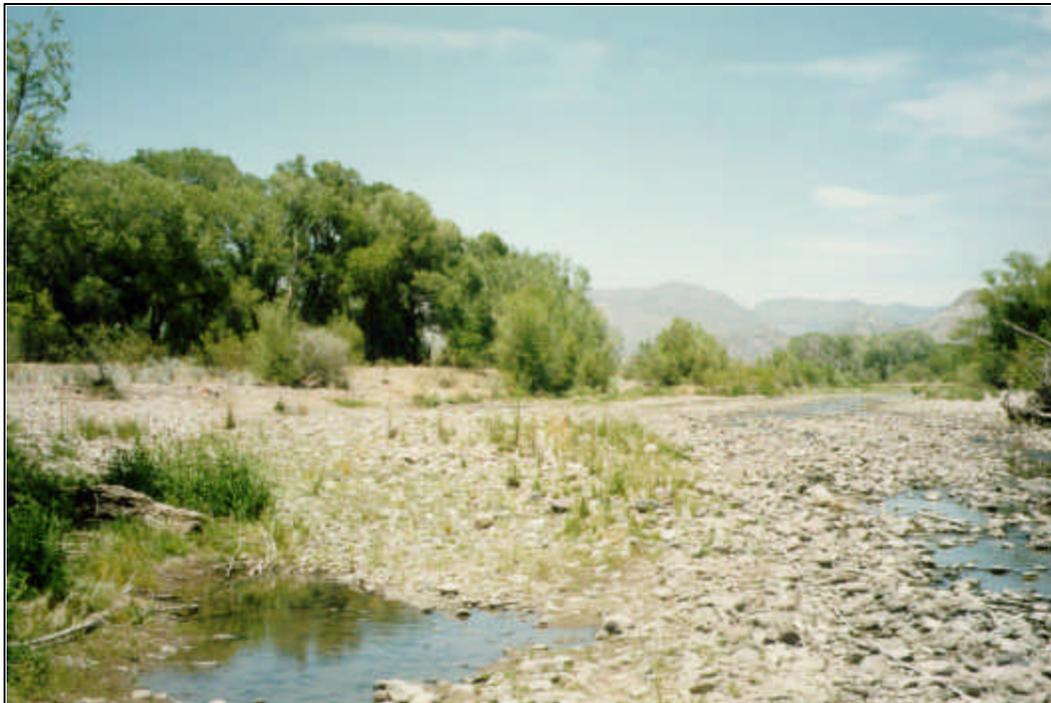
Figure 10. Looking upstream at cross-section 5 location, May 1999. Remnant levee visible in front of large cottonwoods on left side of photo.

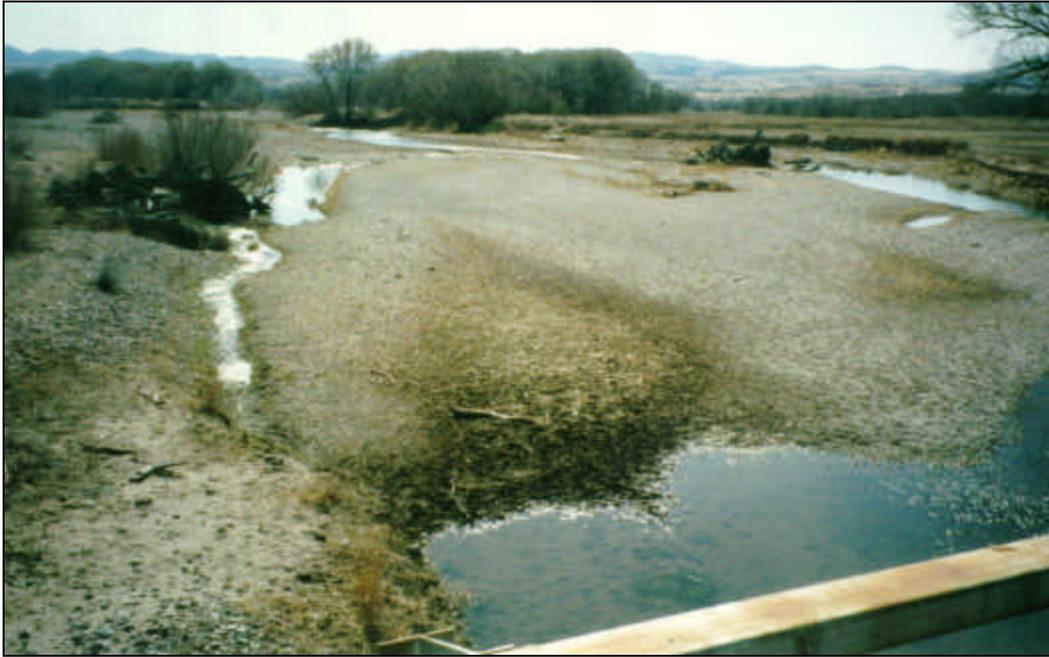
Figure 11. Looking downstream toward cross-section 10 from Highway 211 bridge, March 1999.

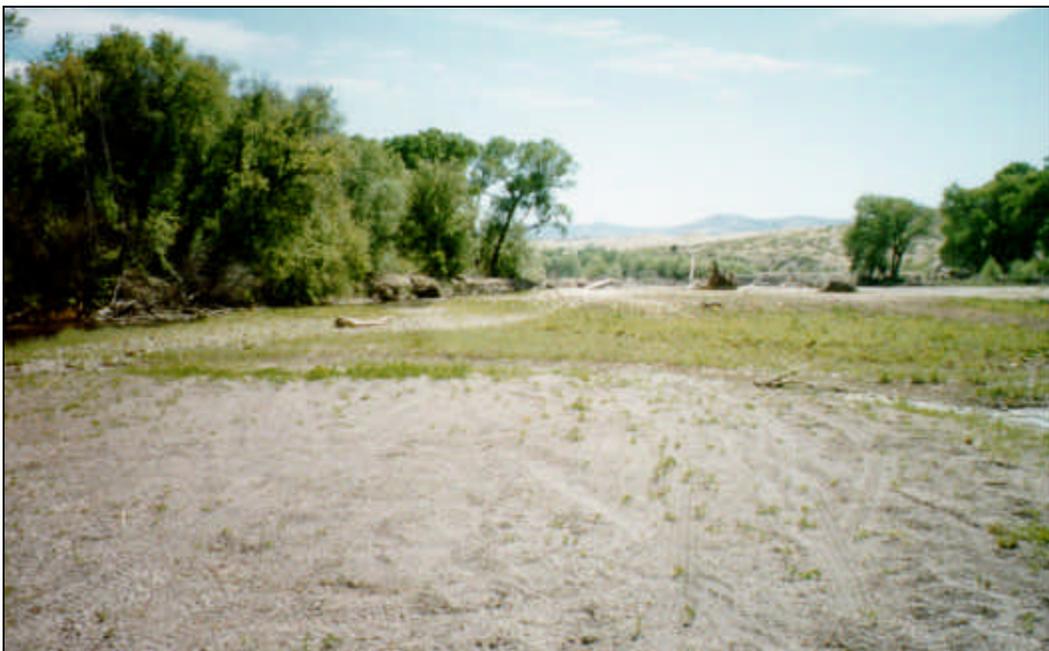
Figure 12. Looking downstream at cross-section 12 location toward Duck Creek confluence, May 1999.

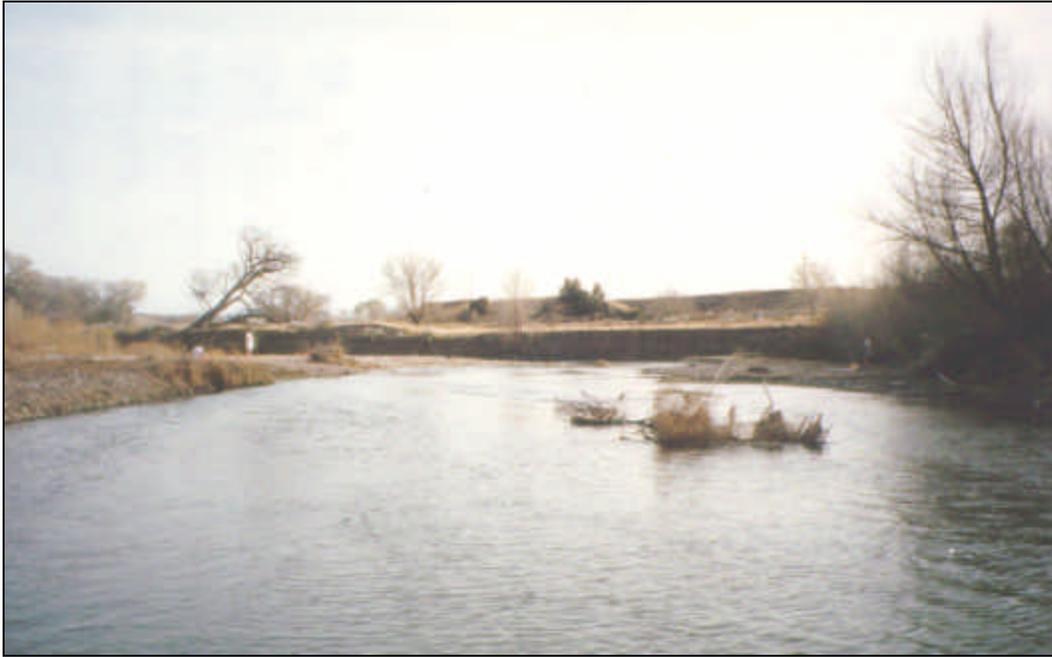
Figure 13. Looking downstream toward cross-section 13 and remnant levee, March 1999.

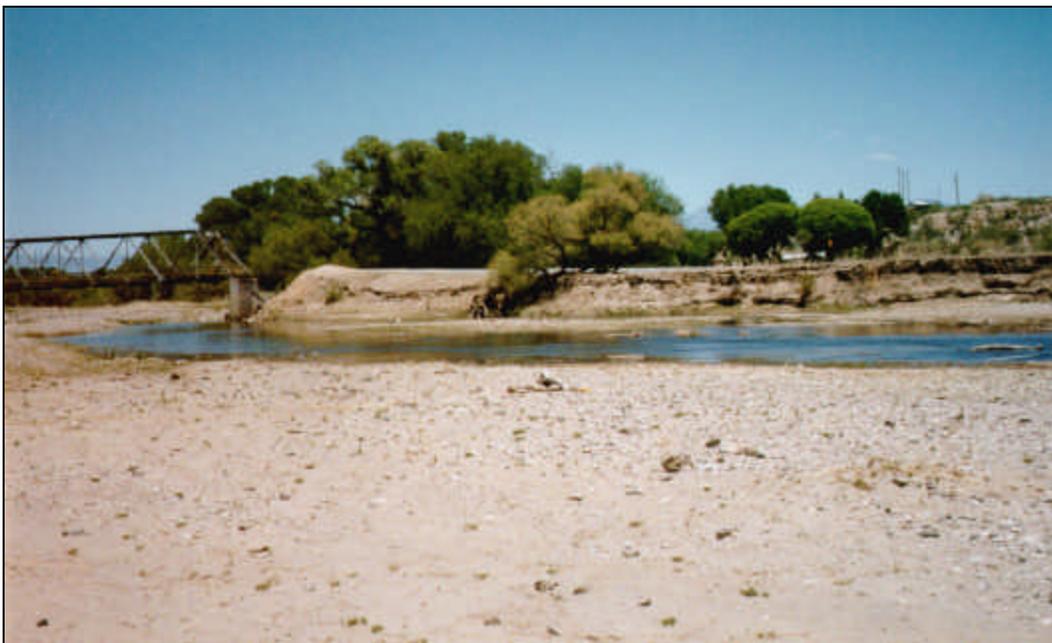
Figure 14. Looking upstream toward eastern end of Iron Bridge at cross-section 14 location, May 1999.

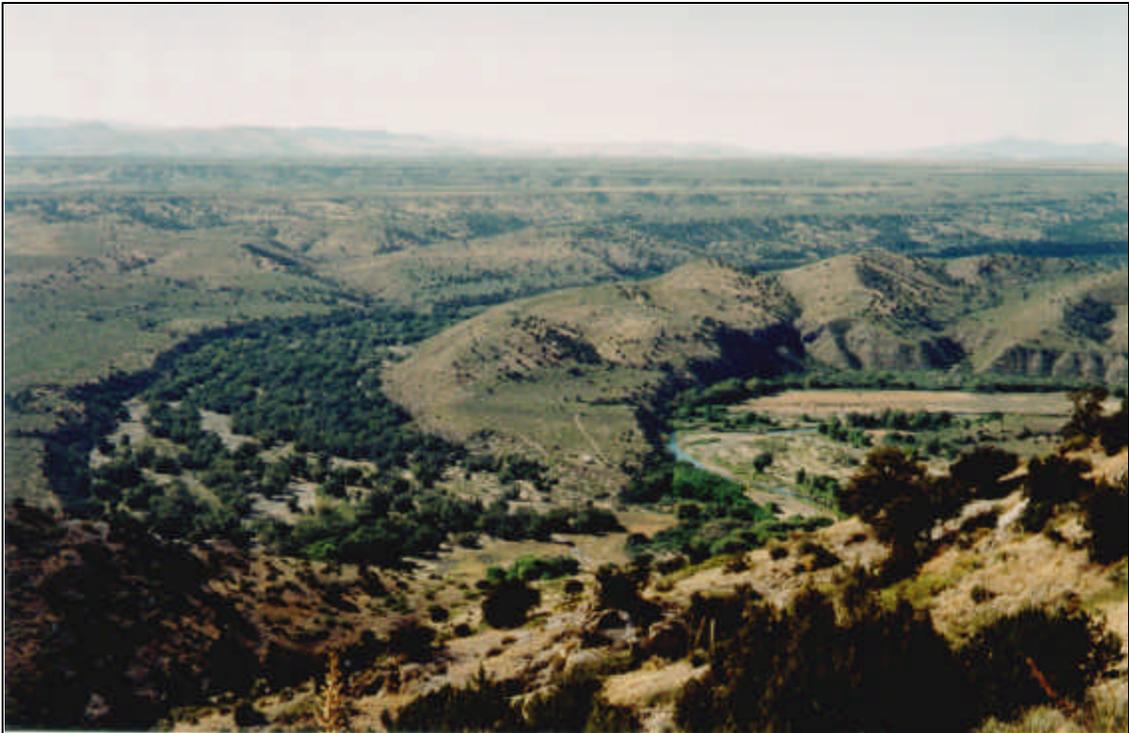
Figure 16. The Gila River (right) and Mogollon Creek (left) at confluence, May 1999. Cross-section 2 is at extreme lower left corner. Flow in Gila is from right to left.

During site visits, I took discharge measurements at one or two locations downstream of the Mogollon Creek confluence. The upstream location (referred to as "xs2") is at the cross-section 2 site, about ¼ mile downstream of the Mogollon Creek confluence and near two piezometers installed for groundwater elevation measurements (see Piezometers, below). Approximately ½ mile farther downstream, a long midchannel bar separates river flow into two channels. The upstream end of the bar is periodically "rebermed" by bulldozer. Each channel formed by the bar meets a ditch diversion point a short distance downstream, and so I refer to this spot as the "diversion split." Two piezometers were also installed near this location.

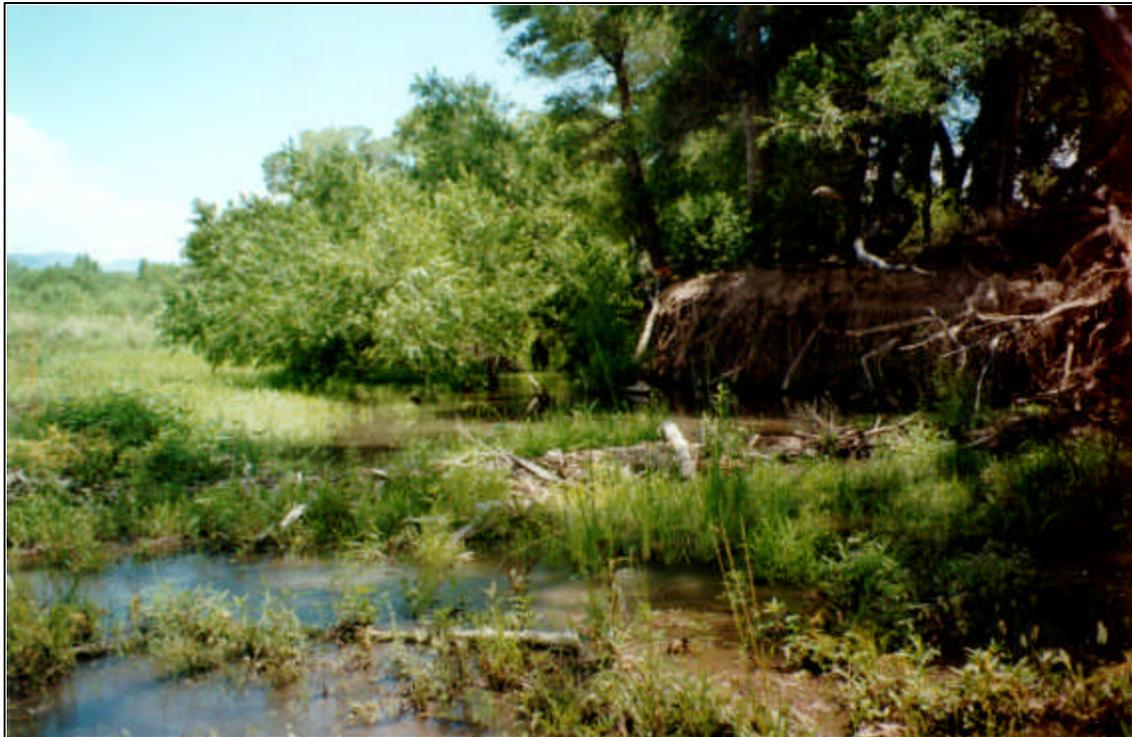
Figure 18. Overflow channel with beaver dam and pond, adjacent to left silt cutbank at cross-section 9, July 1999.

the reach downstream of Spar Canyon, the other, just upstream of the Highway 211 bridge. This group's dam, on the floodplain between the river and the fields to the east, was slightly damaged but not removed by a small flood in August 1999 (Figure 18). Fine sediments accumulate in and around the ponds created by the dams. Whether or not beavers were responsible, the very word "marsh" as a description for the trolley crossing area strongly suggests that a thick layer of fine sediments covered the area in the late 19th century.

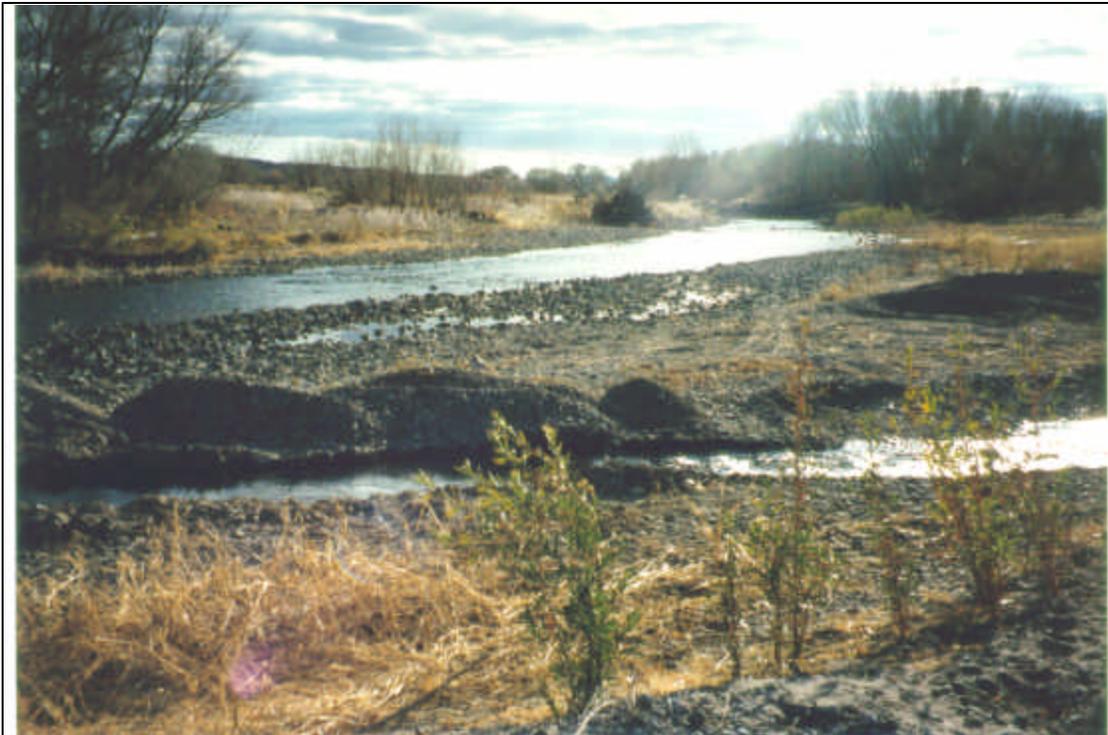
Figure 34. Recent bulldozer work at cross-section 5, September 1999.

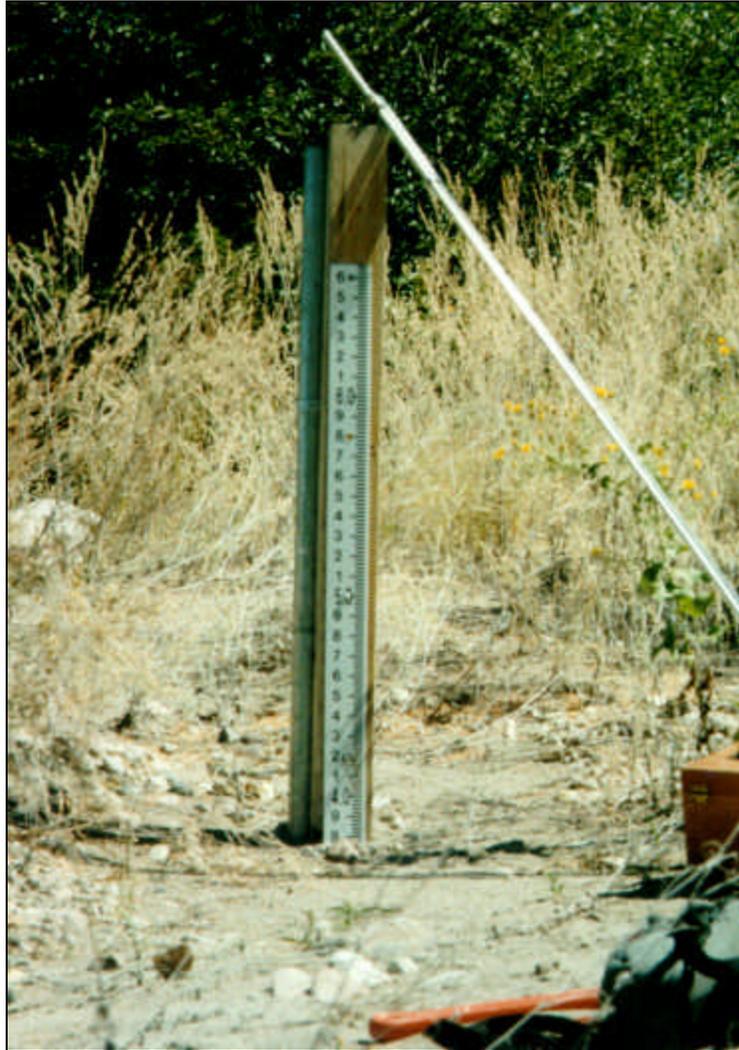
Figure 52. Staff gage at diversion split, September 1999. More than one foot of sand was deposited on this bank by a 2800-cfs flood on August 6, 1999.

on the left bank upstream of the "diversion split" bar, where I installed a staff gage for monitoring river water surface levels. More than a foot of sand was deposited along this bank during the flood (Figure 52).

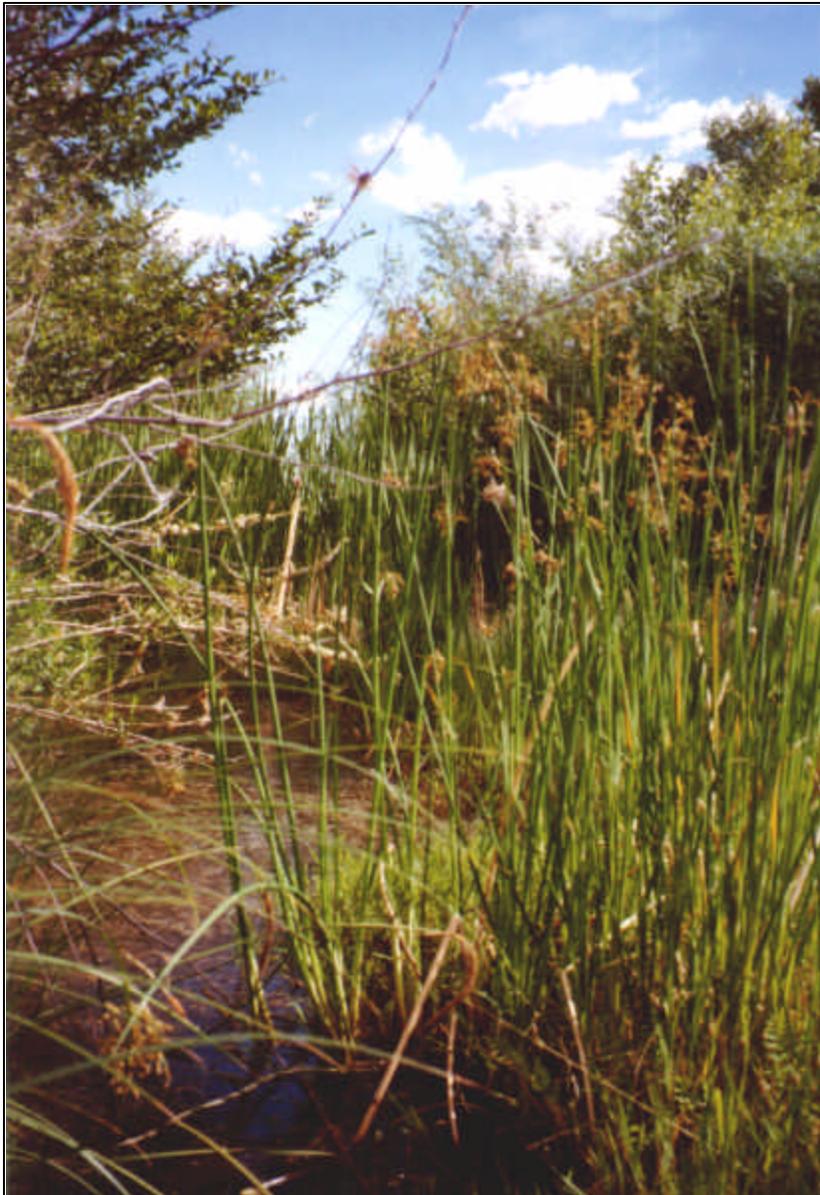
Figure 62. Overflow channel occupying irrigation ditch abandoned ca. 1965, near piezometer 3. May 2000.

P3, which showed the least variation from river surface elevation, was placed on a sand terrace only 20 feet east of an overflow channel that was once the upstream end of the ditch near P5. Water was present in this channel during every site visit, and it hosts a luxuriant growth of reed, forbs, and young cottonwood (see Figure 62). The piezometer site is very close to the old diversion point, and this may be reflected in the lack of variance between river stage and groundwater elevation within the piezometer. Water entering the abandoned ditch flows about the same distance downstream to P3 as it does to the river staff gage where measurements were taken.

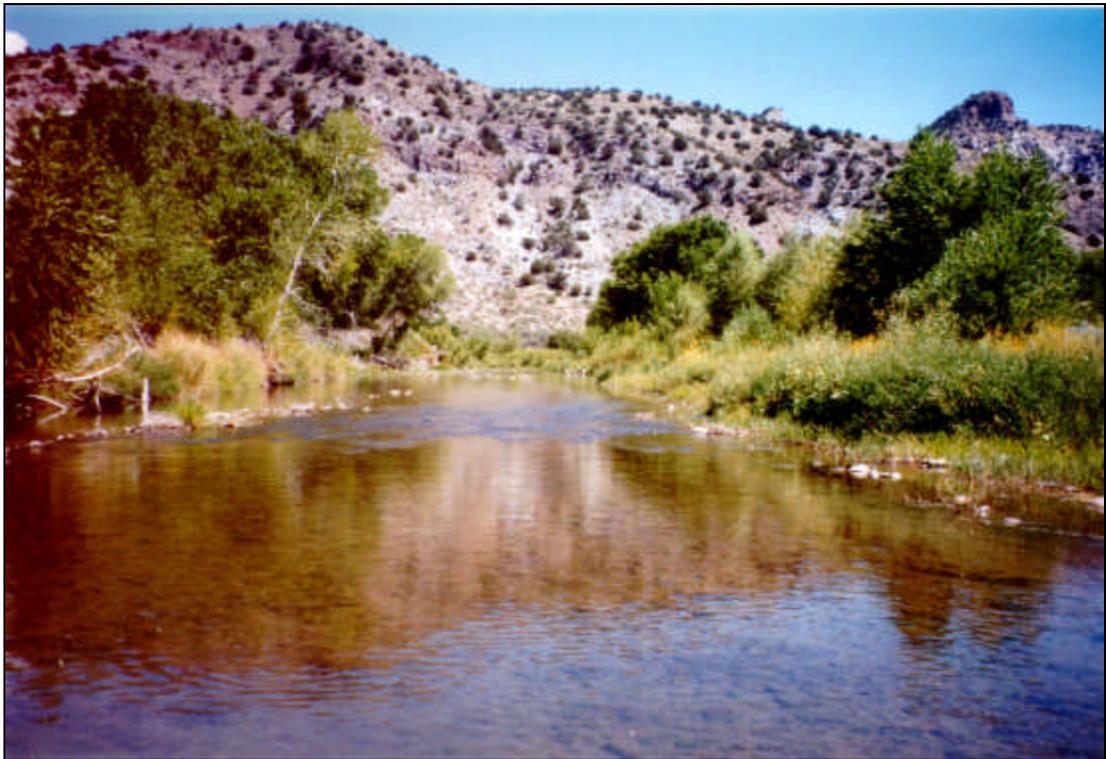
Figure 65. Looking downstream toward location of piezometers P1a and P1b, September 2000. Staff gage visible on left.

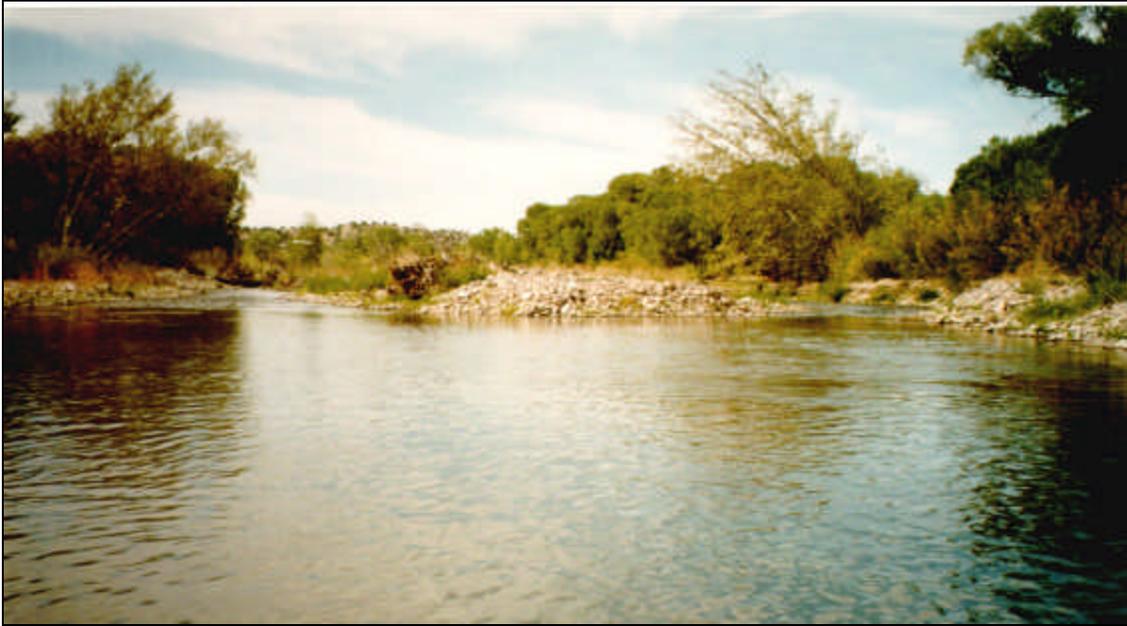
Figure 66. Looking downstream toward bar forming diversion split (center of photo), May 1999.

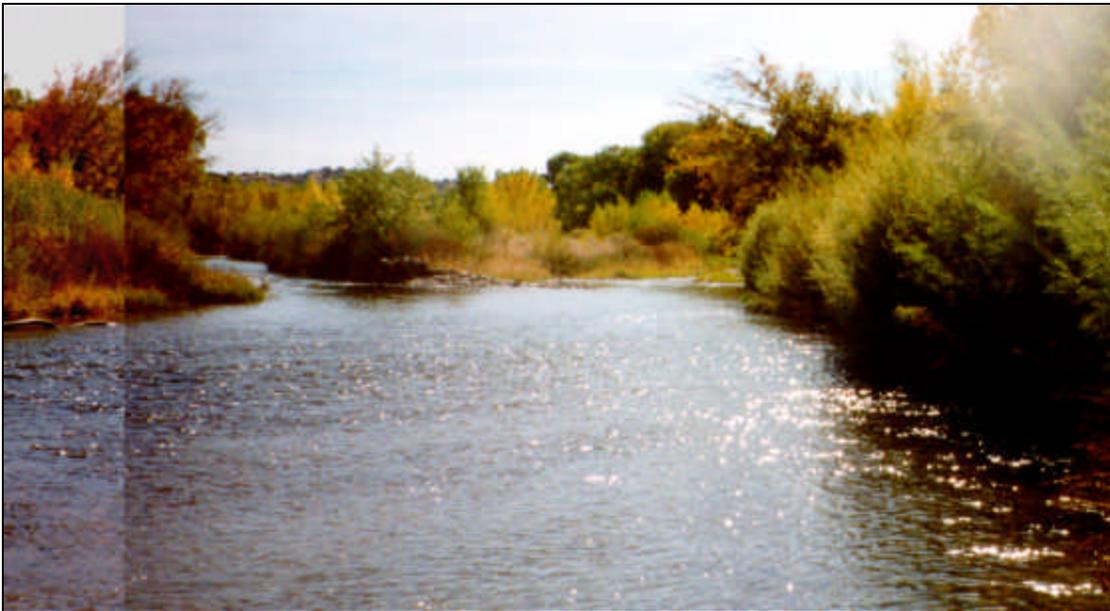
Figure 67. Same view as Figure 66, October 2001.

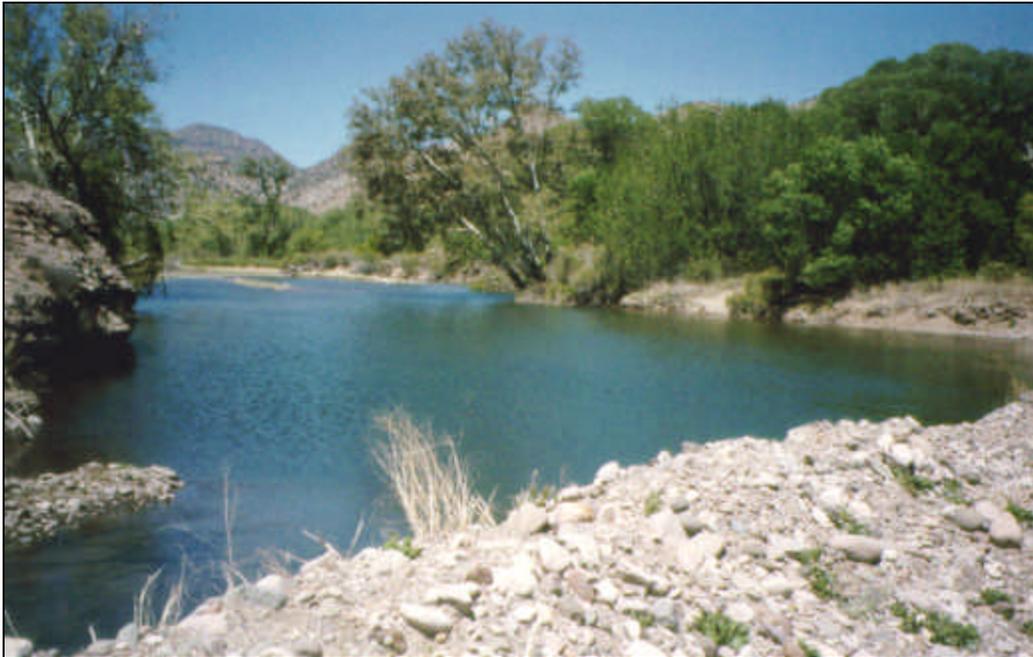
Figure 68. Upper Gila diversion berm in foreground, and reservoir. Berm is approximately 10 feet high. May 1999.

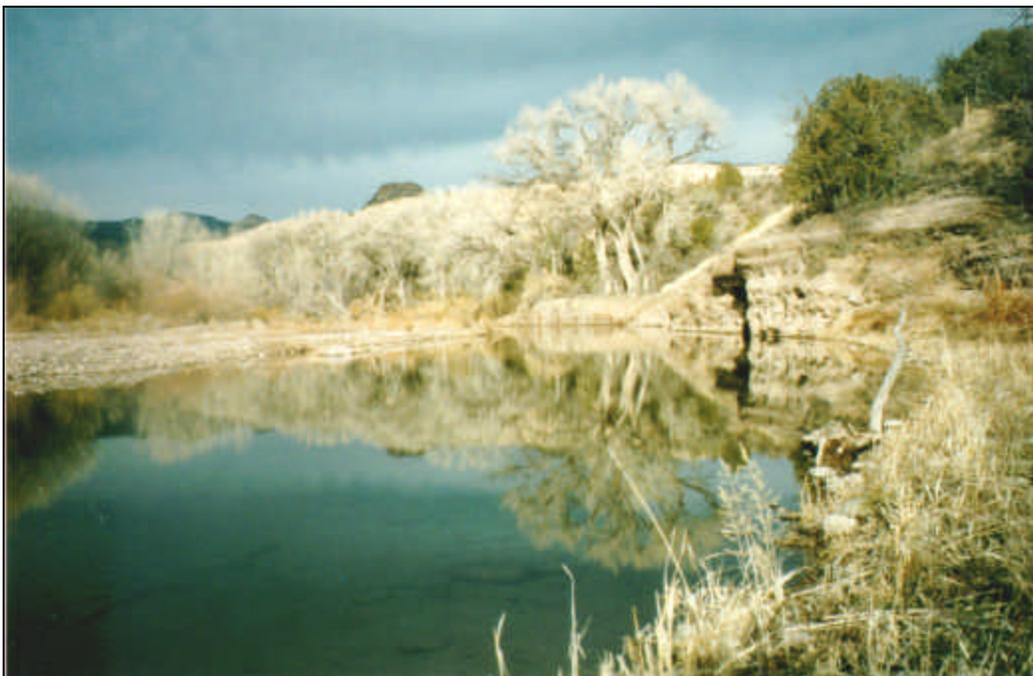
Figure 69. Looking upstream past eight-foot cutbank at mouth of Spar Canyon, on right of photo. January 1999.

The preponderance of meander cuts along non- or sparsely vegetated areas noted previously provides one indication of the potential resistance of floodplain vegetation to flood scour, at least during the majority of flood events in the Gila Valley—perhaps those of recurrence intervals of up to 20 years or more. Another site which has proven extremely resistant to flood scour occurs just upstream of Spar Canyon. The area, depicted as a large green patch, is circled in Figures 39 through 41. Groundwater in this area has long been elevated by the proximity of the small reservoir for the Upper Gila ditch diversion (Figure 68), and all aerial photographs after 1950 show dense riparian growth there. Massive piles of woody flood debris are strewn throughout this area today. Vegetation just upstream, around the short levee constructed at the P5 location and within the constricted reach downstream of it, was almost completely cleared by 1980—either by the 1978 flood, bulldozer work, or both. Yet vegetation between the reservoir area and river channel remained intact during the 1978 flood—and all later floods. In fact, the area's resistance to floods is at least partly responsible for the river's lateral erosion toward the east, through part of the Spar Canyon alluvial fan and into the mouth of the canyon. Although coarse materials at the base of Spar Canyon maintained the river's meander to the west between 1917 and at least 1974, the high-magnitude 1978 flood marked the beginning of eastward lateral erosion through these deposits. Lateral movement proceeded in later floods and became responsible for much of the present-day downcutting in Spar Canyon. Figure 69 documents the resulting eight-foot cutbank at the base of the canyon.
